# New Generation Runway Visual Range (RVR) Final Operational Test and Evaluation Report: Volume III

DOT/FAA/CT-TN95/32-III

This report will detail testing and results conducted on the New Generation Runway Visual Range (RVR) Visibility Sensor (VS) at the Cold Regions Research and Engineering Laboratories (CRREL). Extensive testing was performed on the sensor over a six week period from July 1993 to August 1993. Comments and conclusions for each test as well as ACW-200B recommendations and conclusions are detailed within the remainder of the report.

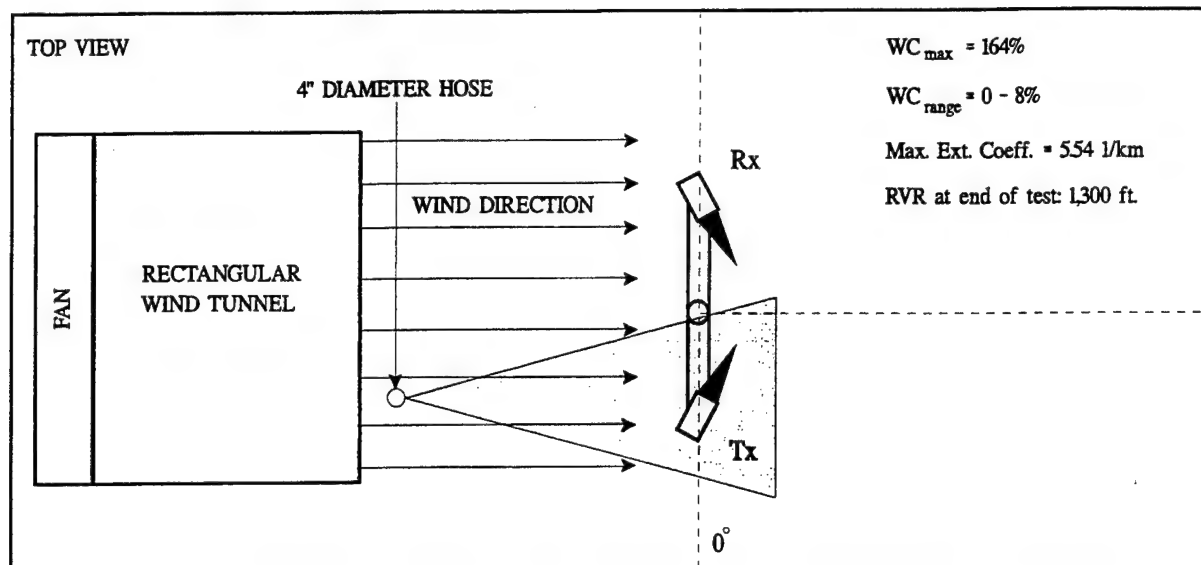
Figure 28. LKDWN VS Blowing Snow Test at 0° (Tx) - Location: ROWPU Chamber

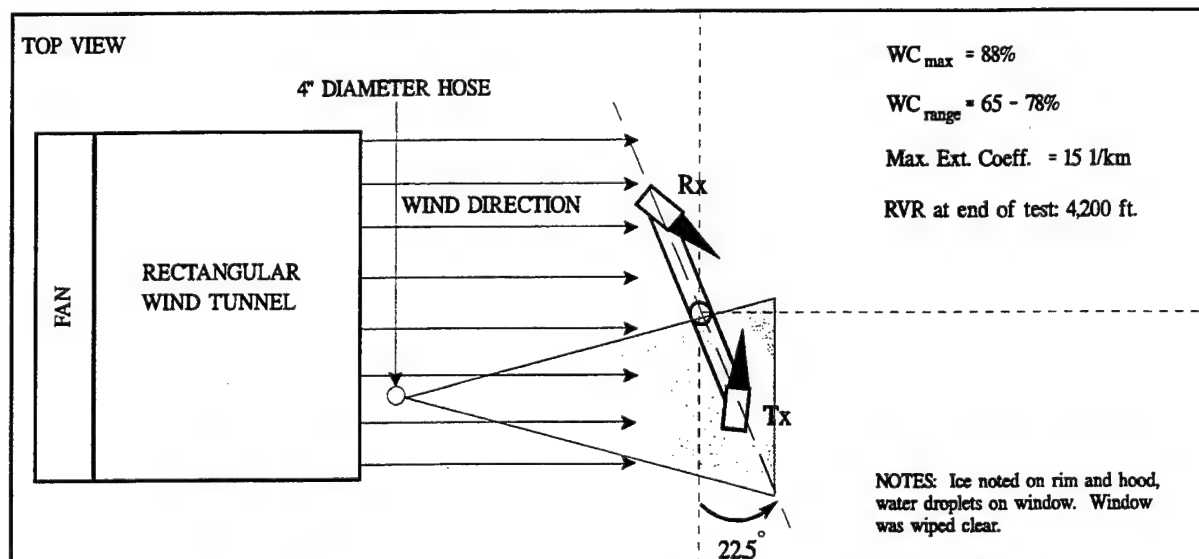
Figure 29. LKDWN VS Blowing Snow Test at 22.5° (Tx) - Location: ROWPU Chamber

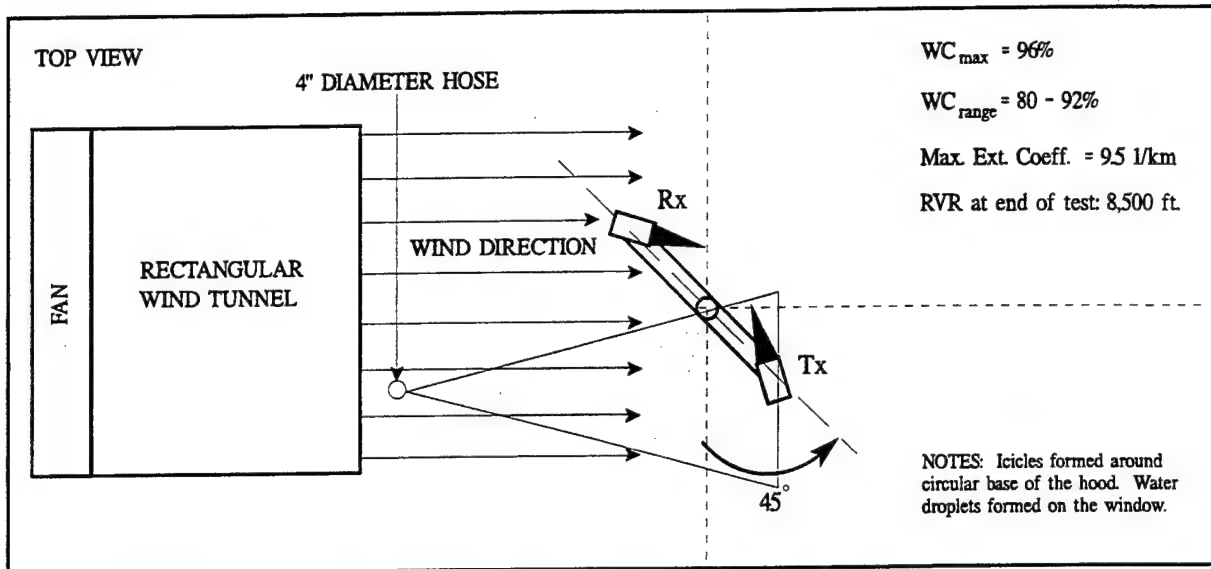
Figure 30. LKDWN VS Blowing Snow Test at 45° (Tx) - Location: ROWPU Chamber

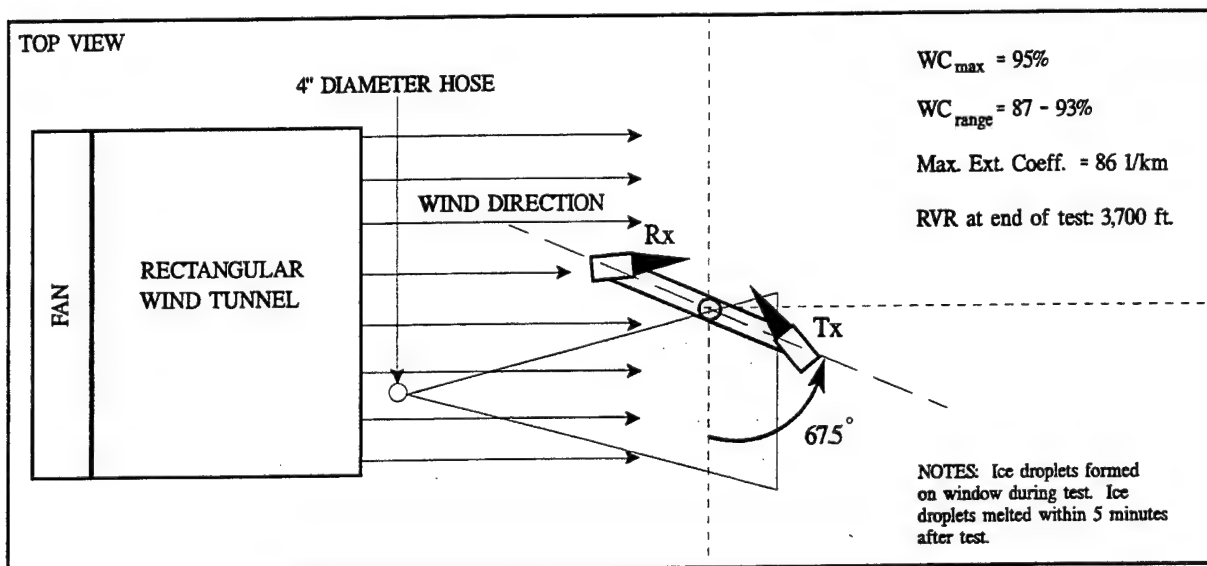
Figure 31. LKDWN VS Blowing Snow Test at 67.5° (Tx) - Location: ROWPU Chamber

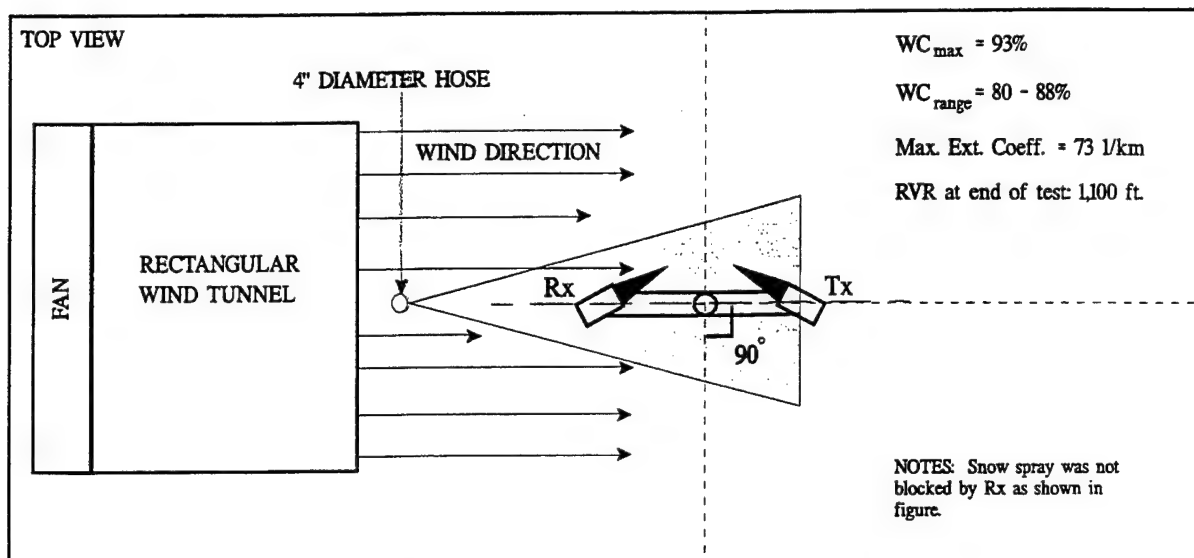
Figure 32. LKDWN VS Blowing Snow Test at 90°(Tx) - Location: ROWPU Chamber

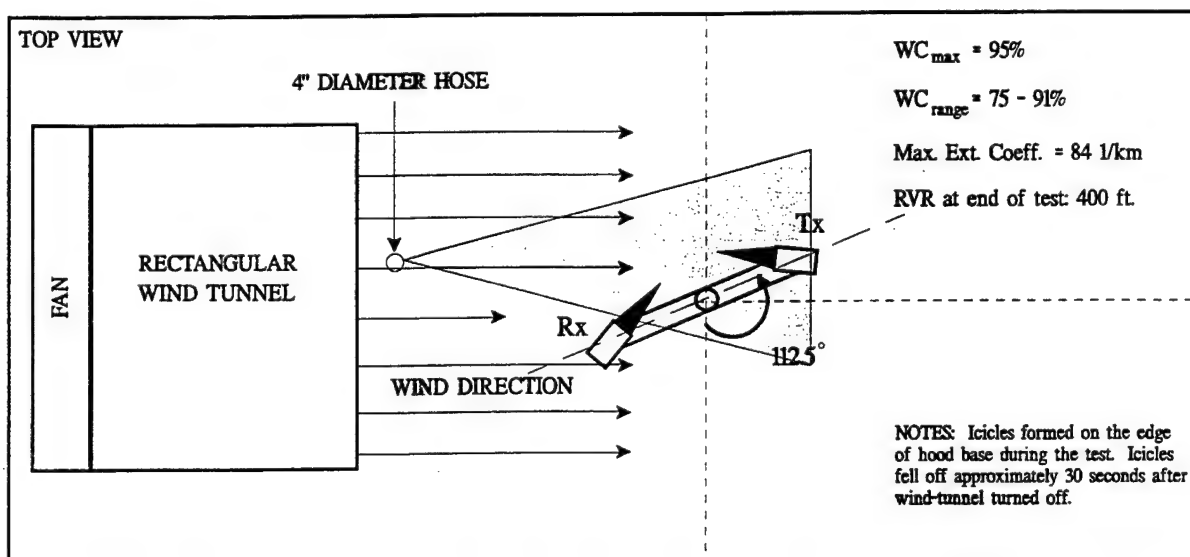
Figure 33. LKDWN VS Blowing Snow Test at 112.5°(Tx) - Location: ROWPU Chamber

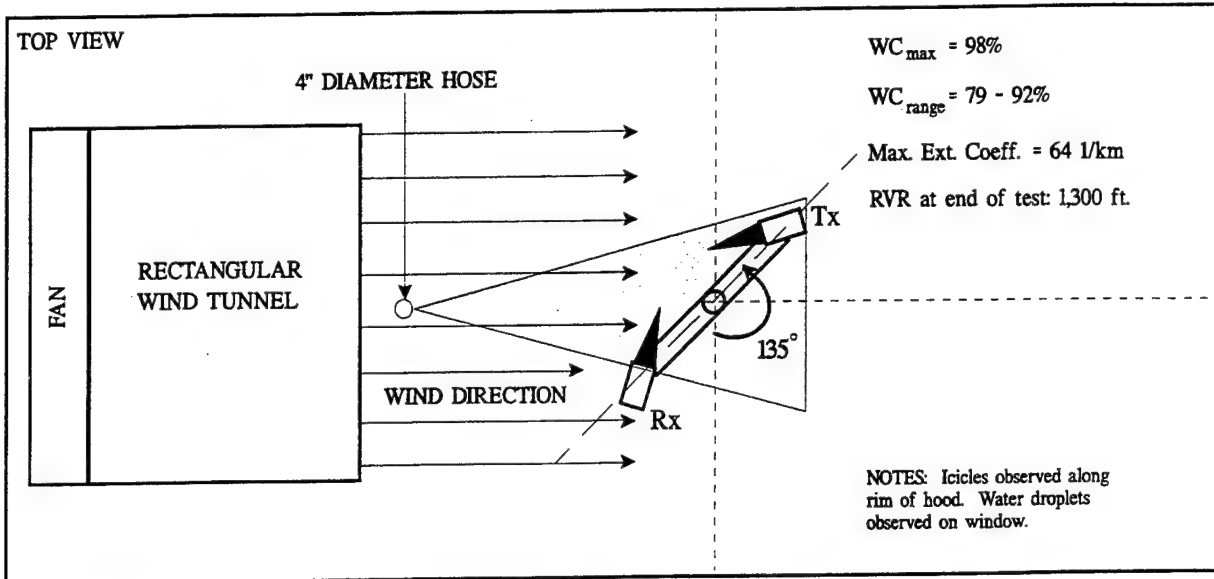
Figure 34. LKDWN VS Blowing Snow Test at 135° (Tx) - Location: ROWPU Chamber

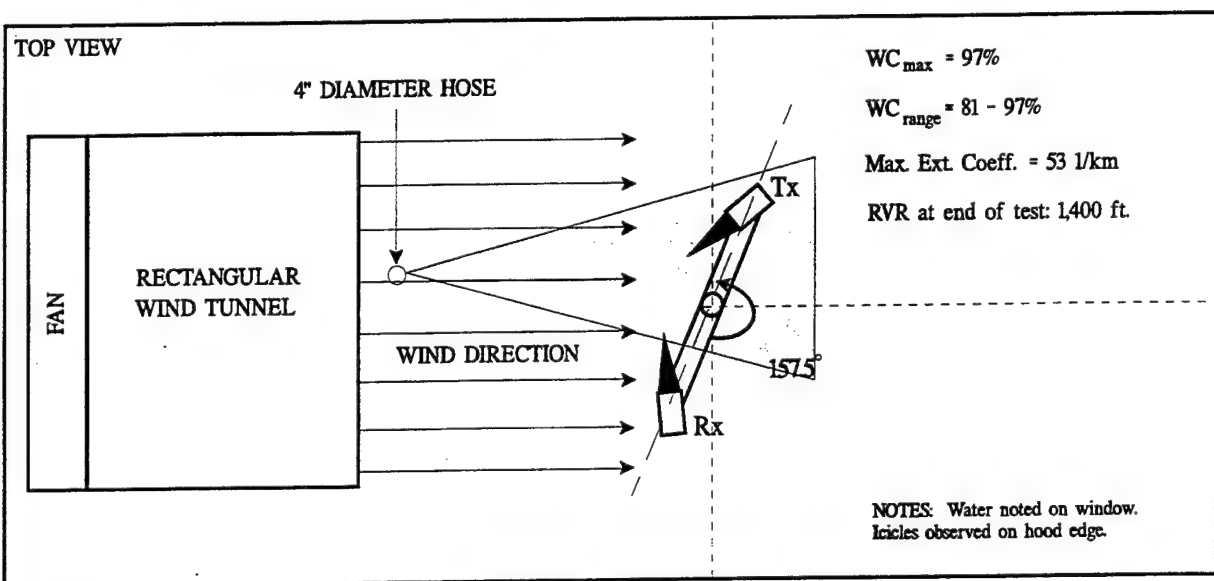
Figure 35. LKDWN VS Blowing Snow Test at 157.5° (Tx) - Location: ROWPU Chamber

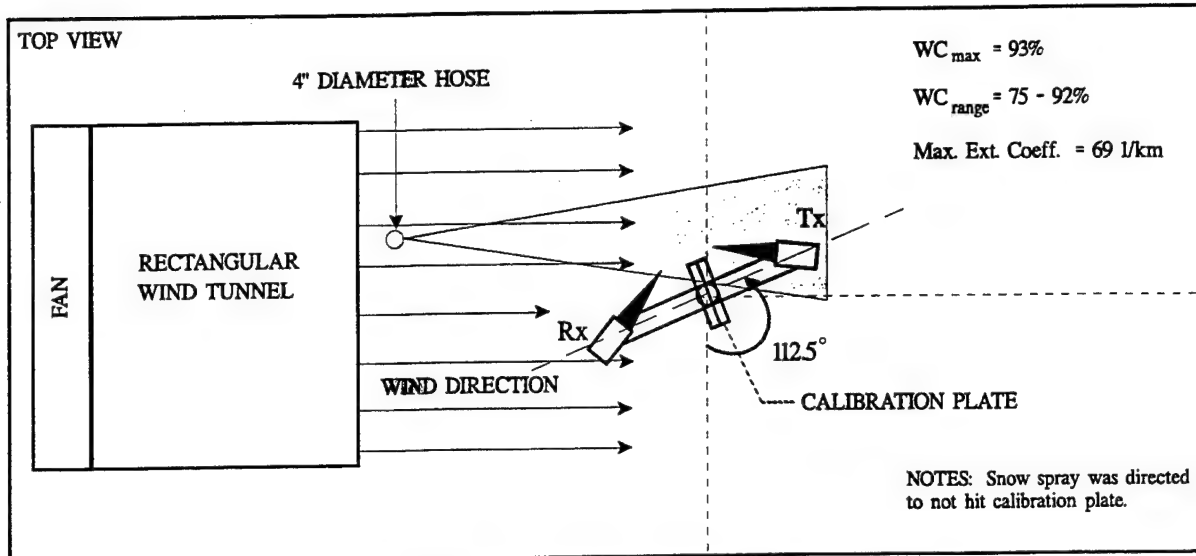
Figure 37. LKDWN VS Blowing Snow Test w/ Calibration Plate (Tx) at 112.5° - Location: ROWPU Chamber

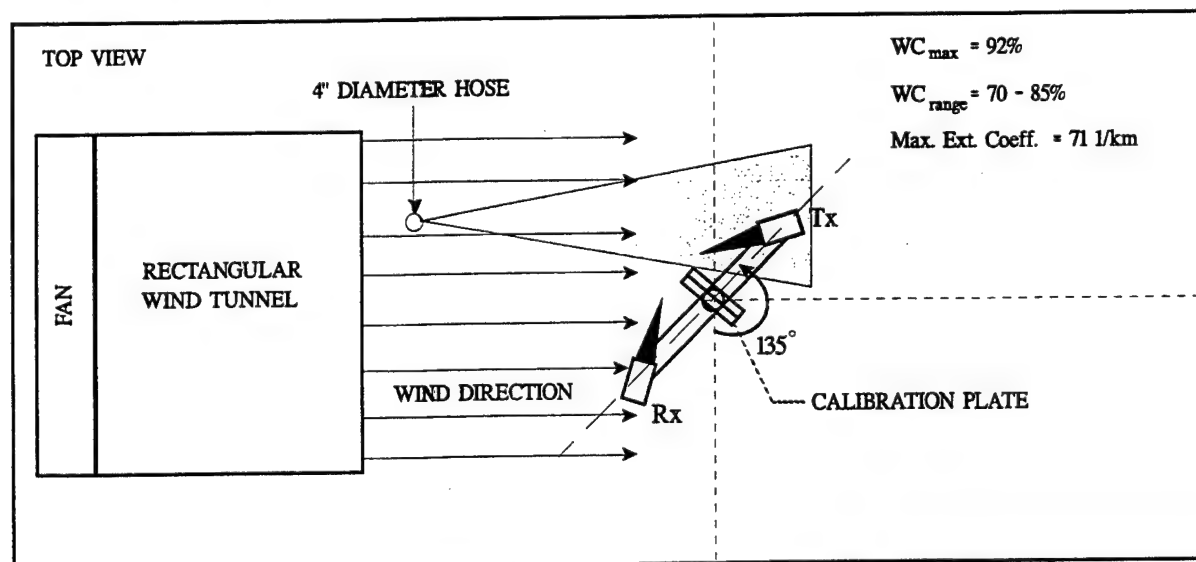
Figure 38. LKDWN VS Blowing Snow Test w/ Calibration Plate (Tx) at 135° - Location: ROWPU Chamber

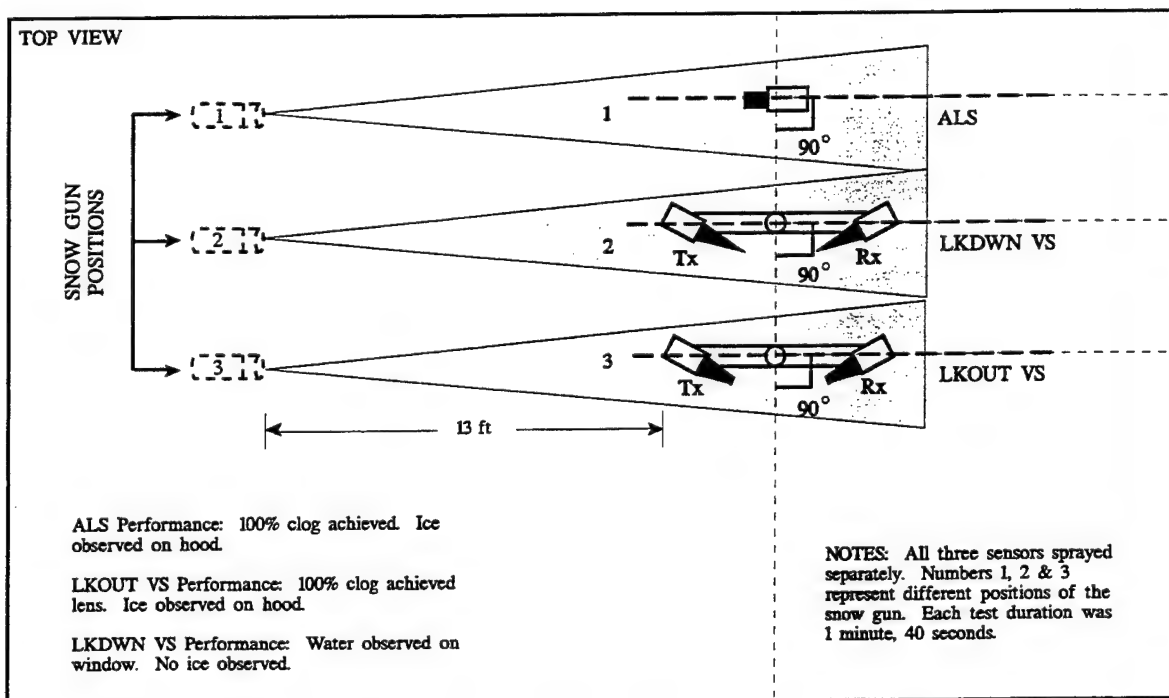
Figure 40. Blowing Snow Test w/ Snow Gun at 90° - Location: ROWPU Chamber

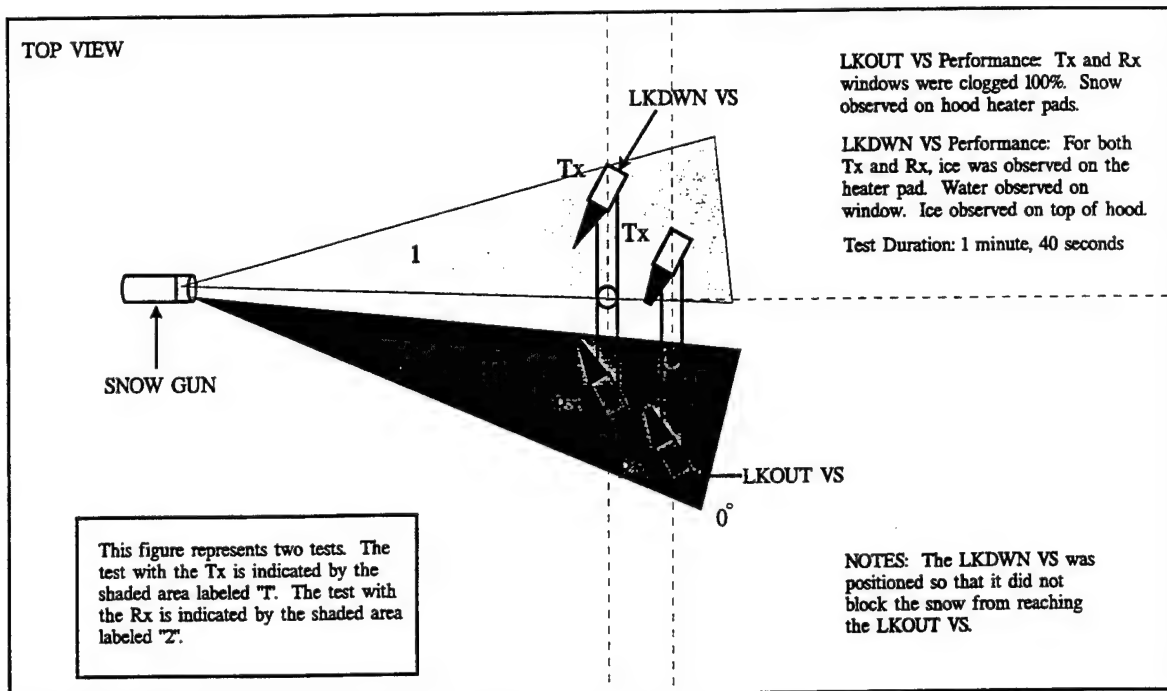
Figure 41. Blowing Snow Test w/ Snow Gun (Rx & Tx) at 0° - Location: ROWPU Chamber

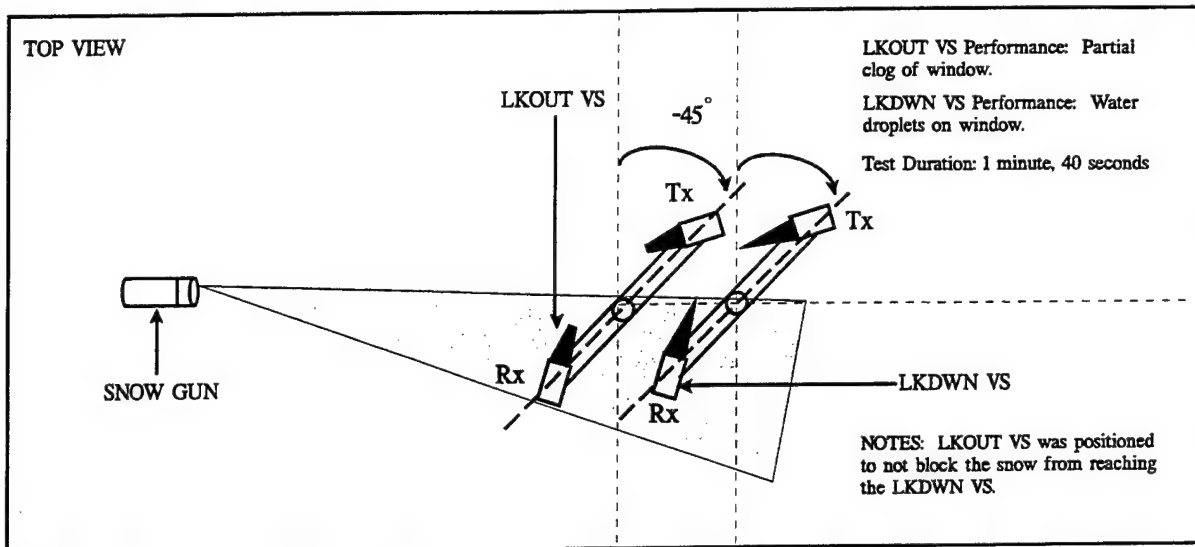
Figure 43. Blowing Snow Test w/ Snow Gun (Rx) at -45° - Location: ROWPU Chamber

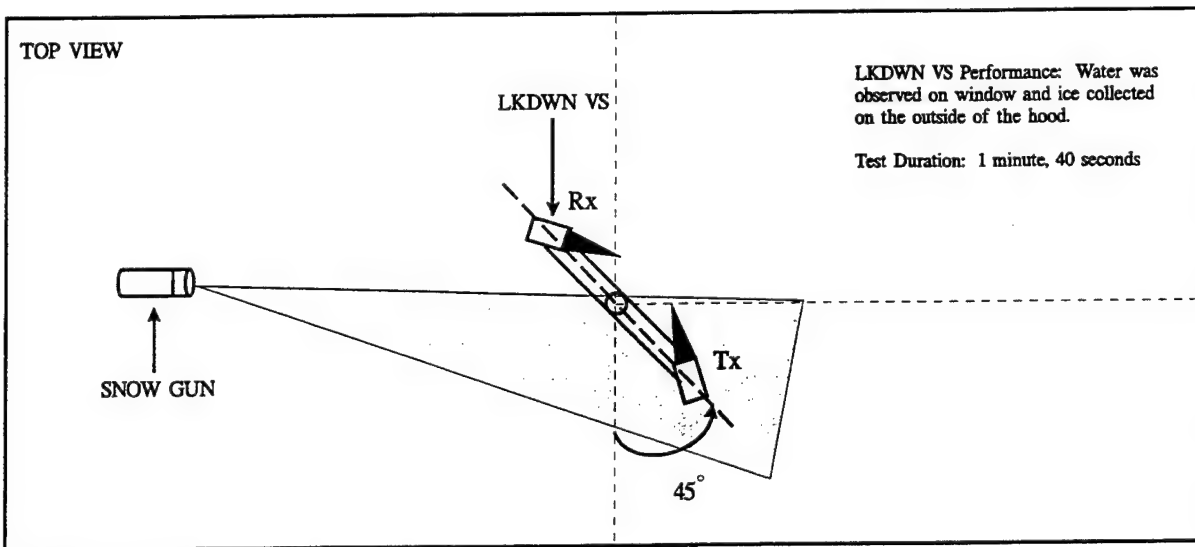
Figure 44. Blowing Snow Test w/ Snow Gun (Tx) at 45° - Location: ROWPU Chamber

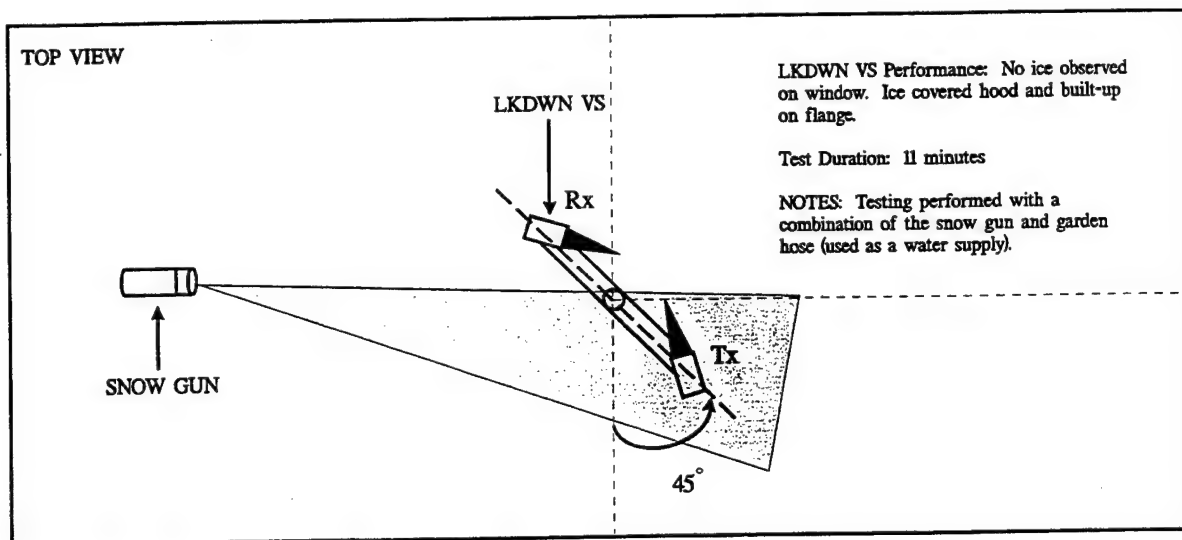
Figure 45. Blowing Snow Test w/ Snow Gun (Tx) at 45° - Location: ROWPU Chamber

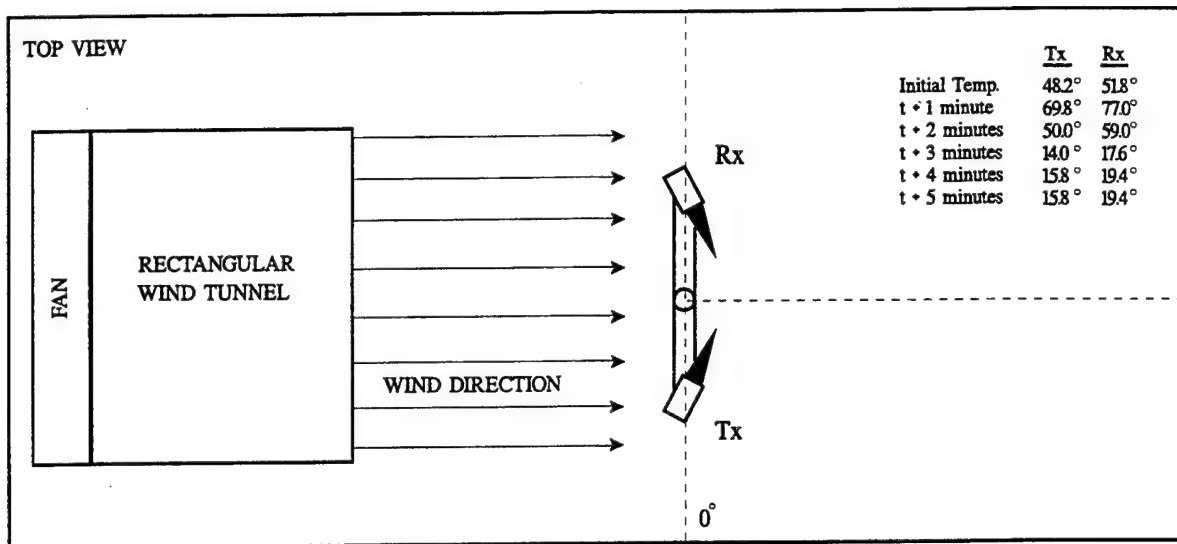
Figure 46. TX RX Temp Diff Test 1 at 0° - Location: ROWPU Chamber

Although separate transmitter and receiver heater controls could optimize sensor performance in terms of power conservation, the results indicate that the transmitter and receiver temperature differences are small. Hence, a change in heater control scheme based solely on transmitter and receiver temperature differences is not warranted.

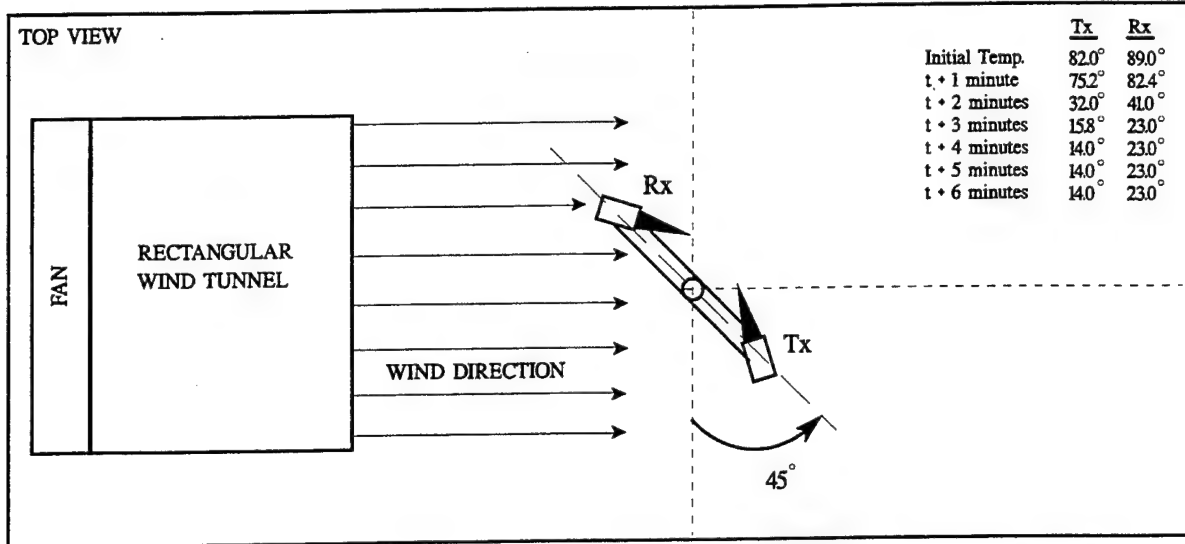
Figure 48. TX RX Temp Diff Test 1 at 45° (Rx Closer to Fan) - Location: ROWPU Chamber

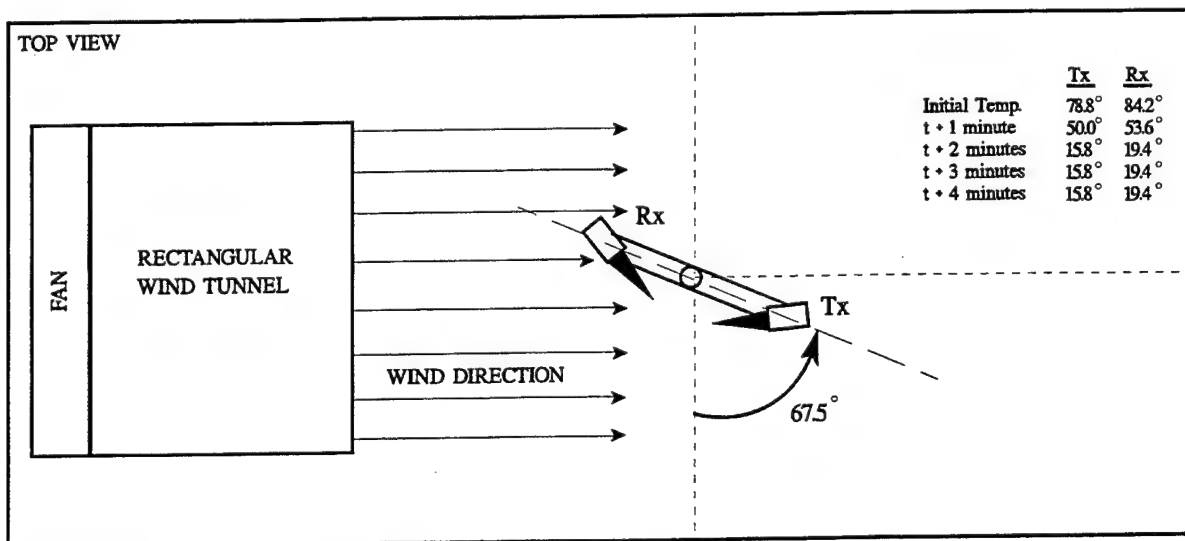
Figure 49. TX RX Temp Diff Test 1 at 67.5° (Rx Closer to Fan) - Location: ROWPU Chamber

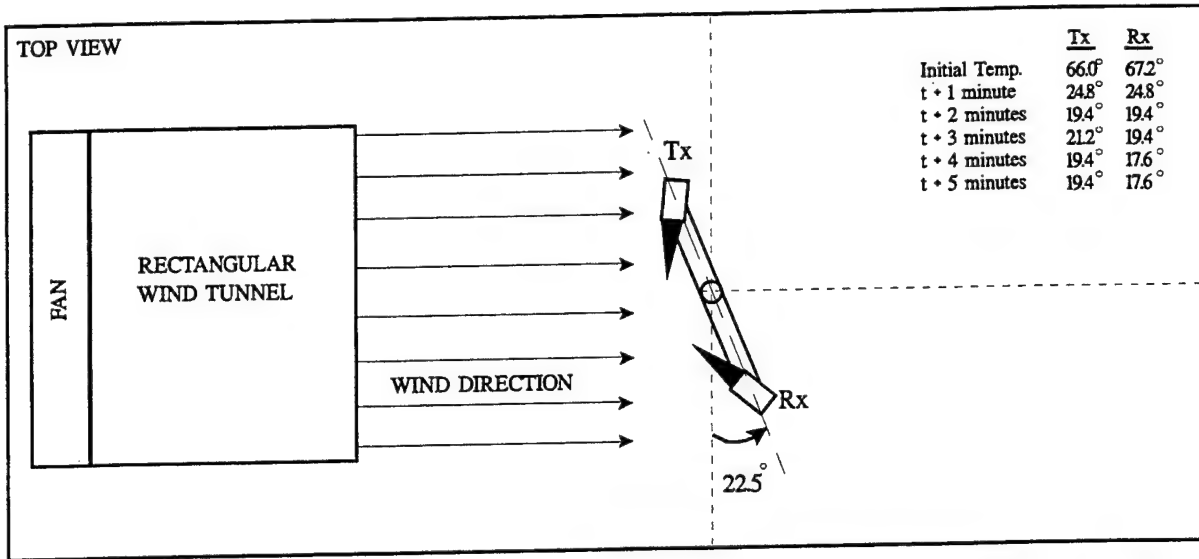
Figure 52. TX RX Temp Diff Test 1 at 22.5° (Tx Closer to Fan) - Location: ROWPU Chamber

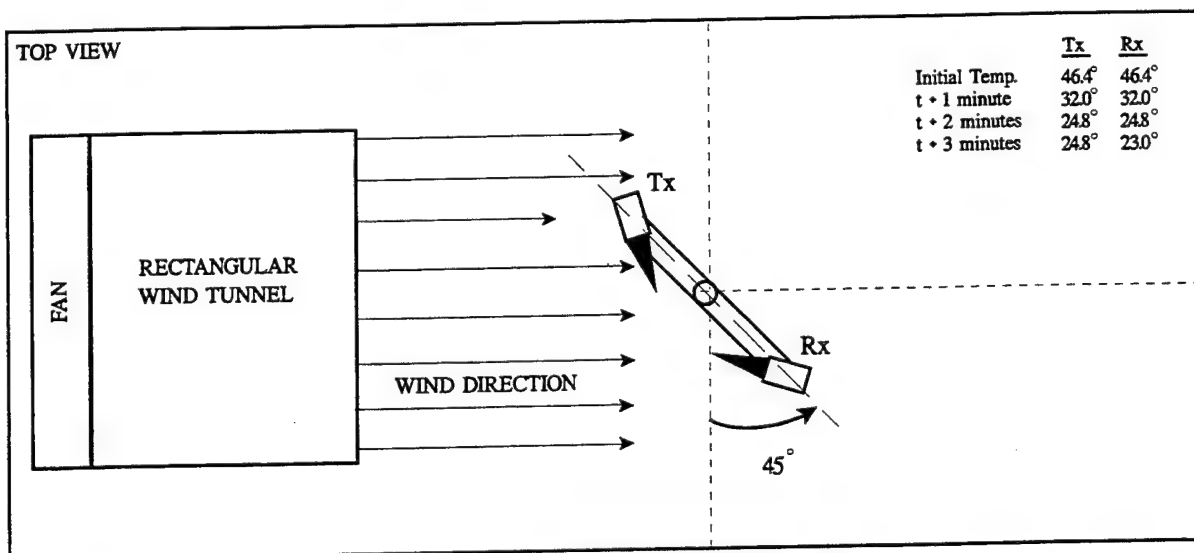
Figure 53. TX RX Temp Diff Test 1 at 45° (Tx Closer to Fan) - Location: ROWPU Chamber

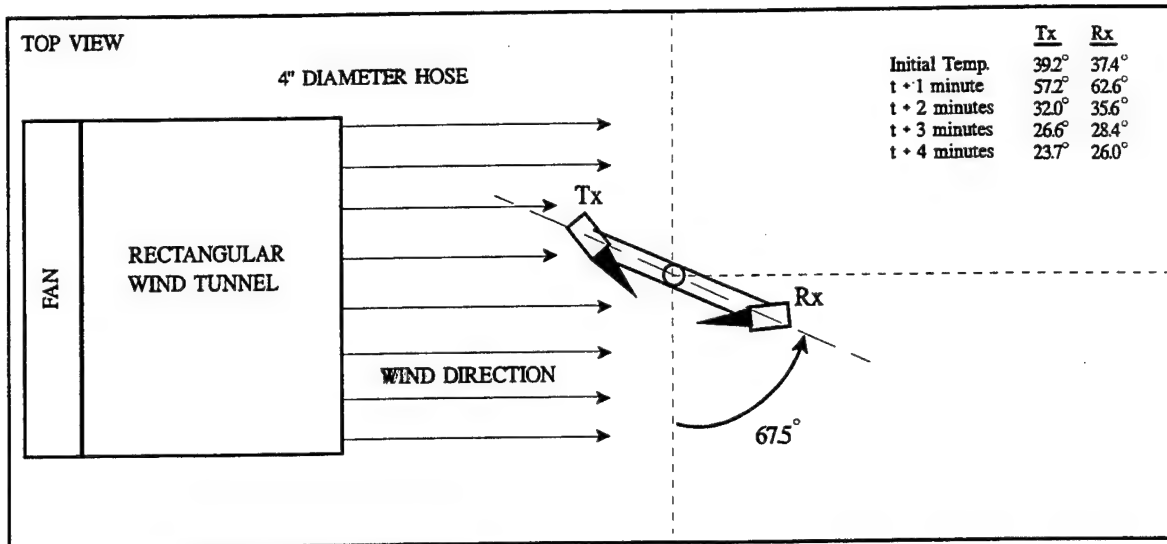
Figure 54. TX RX Temp Diff Test at 67.5° (Tx Closer to Fan) - Location: ROWPU Chamber

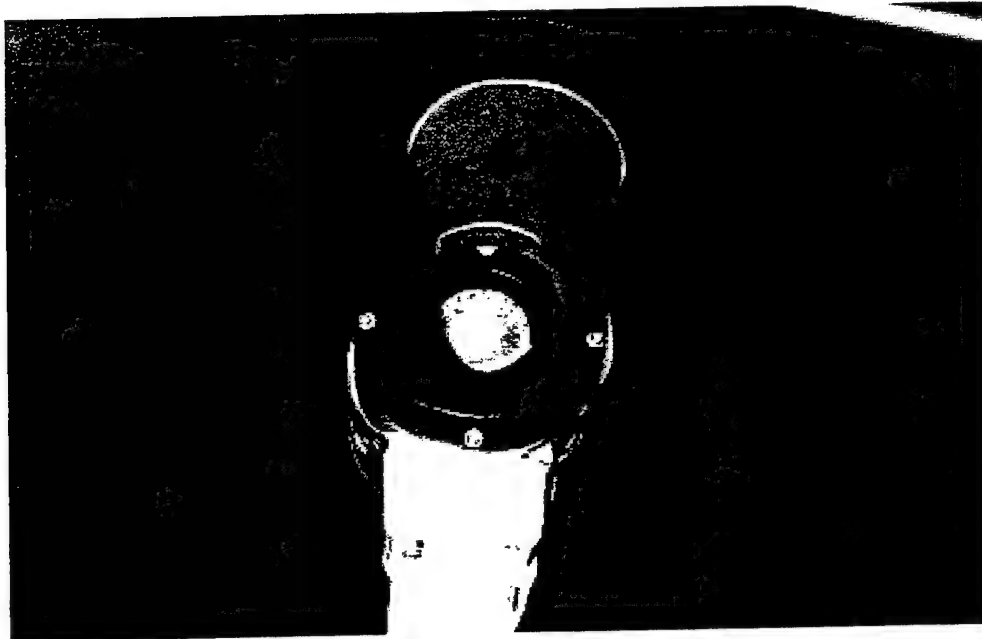
PHOTO 6. LOOK-DOWN VS SNOW CLOG "THIN" AT CENTER

The fact that a larger clog was formed suggests that the de-ice heater should not be disabled at  $1.4^{\circ}$ , despite the inadvertent drop in chamber temperature. However, a repeat of this test at a constant temperature would most likely result in less performance degradation with a deactivated de-ice heater.

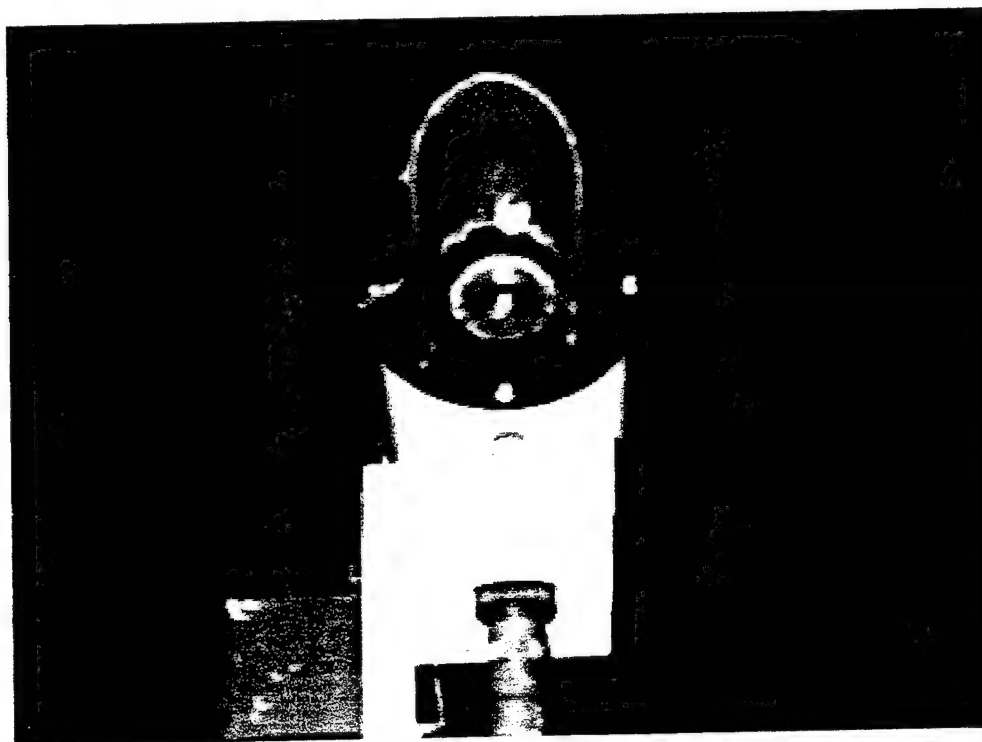
PHOTO 7. ALS "DONUT CLOG"

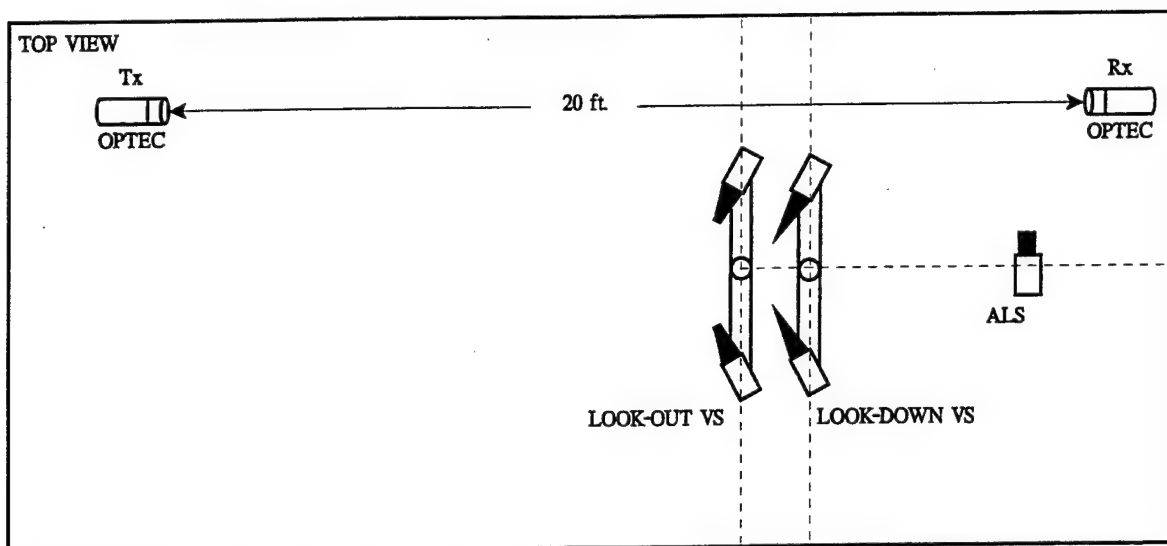
Figure 60. Fog w/ Snow Gun Test 1-3 - Location: ROWPU Chamber

The second fog test was also conducted on August 24, 1993 in the ROWPU Chamber. The Look-Down VS, Look-Out VS and Optec transmissometer were positioned as in the previous test. To attempt to increase the correlation of the VS measurements, the Look-Down VS was recalibrated to be 30% higher than the Look-Out VS calibration value.

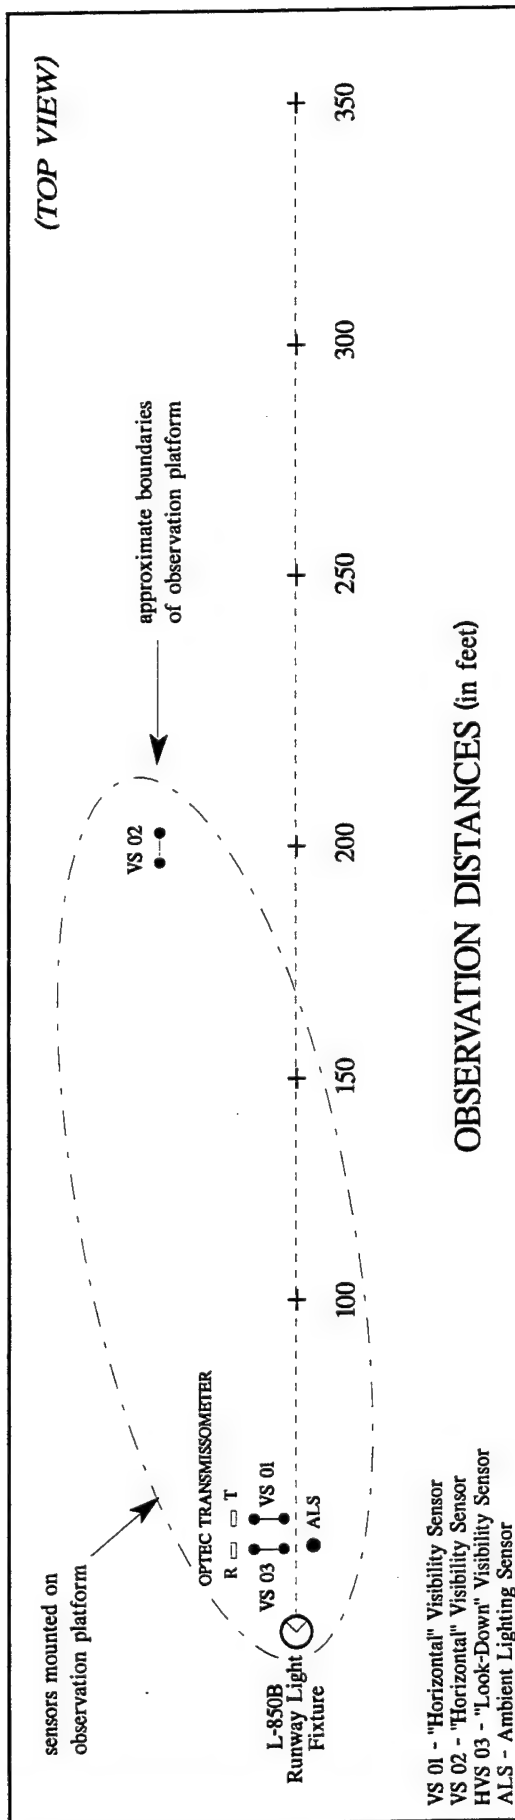
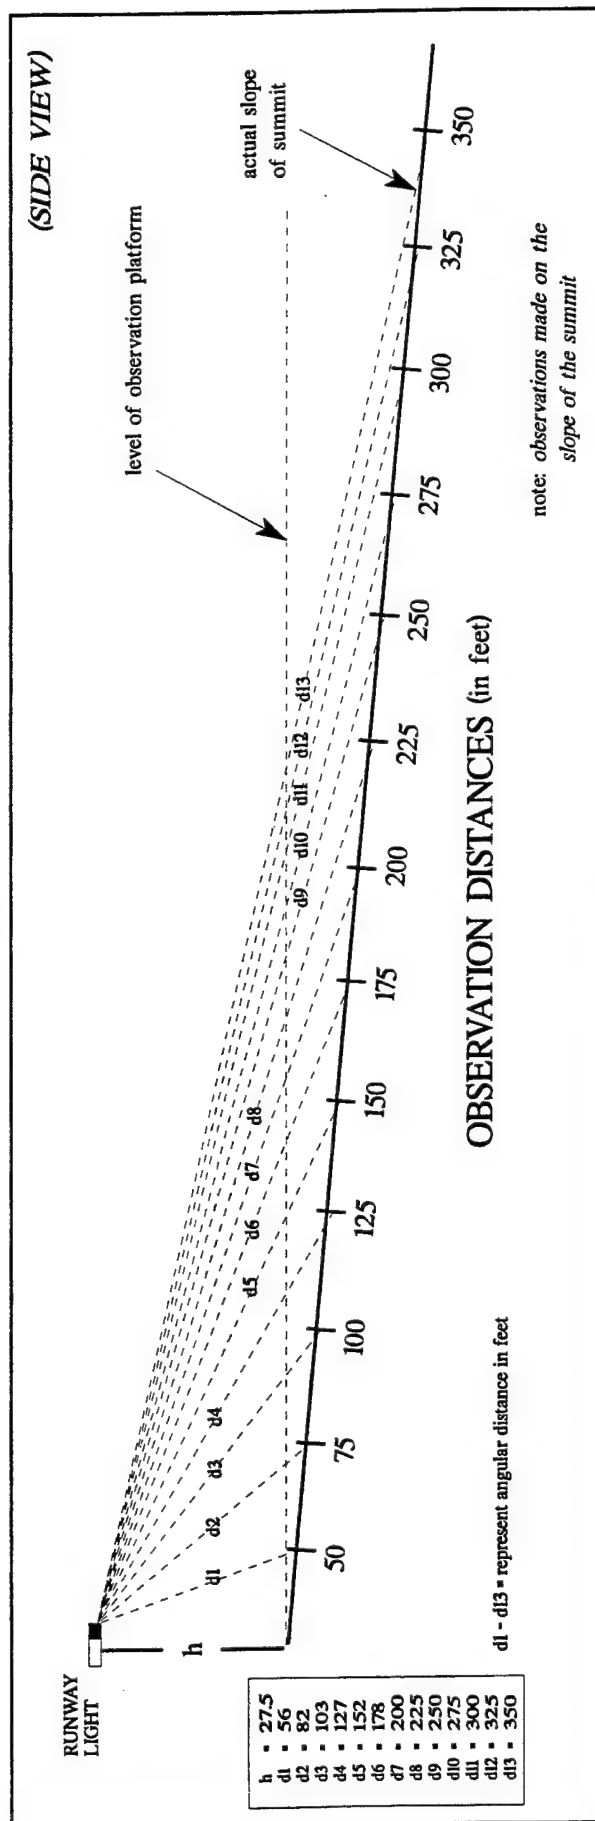
Figure 1-1a

# CATEGORY IIIb TEST LAYOUT

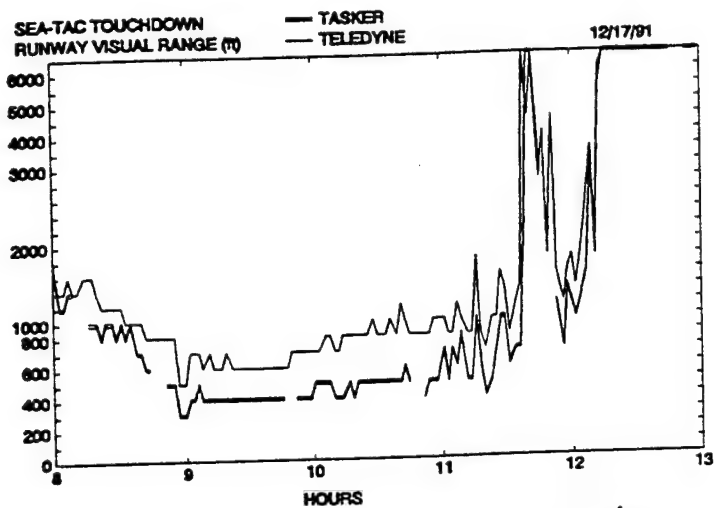
Figure 2. Sea-Tac RVR at Touchdown Location

Figures 2 and 3 compare sample RVR measurements at the touchdown location from the Tasker and Teledyne systems for Sea-Tac and Bangor, respectively. In general, the values from the two systems track, but the Teledyne values are consistently higher than the Tasker values. The Sea-Tac (Figure 2) show typical differences of two or three reporting increments. The Bangor data (Figure 3) showed better agreement, i.e. typical differences of one or two reporting increments. As will be shown below, most of the difference was caused by calibration errors in the Teledyne visibility sensors. It should be kept in mind, however, that slightly different equations are used to calculate RVR by the two systems. A more accurate comparison of the RVR from the two systems will result from using exactly

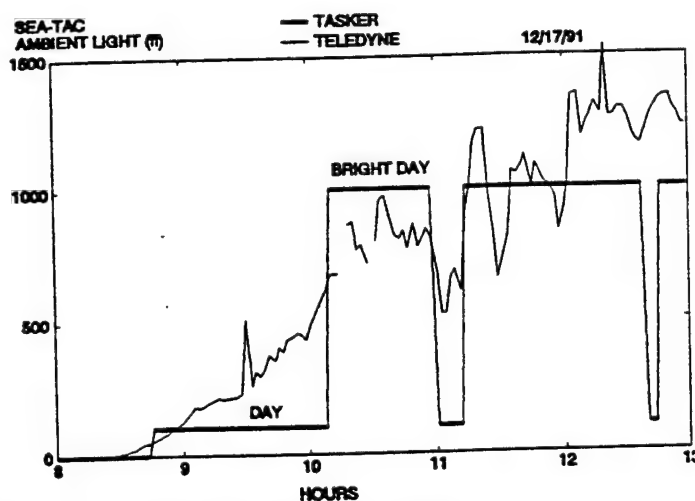
Figure 6. Sea-Tac Ambient Light

four ambient light levels (night, twilight, day and bright day) depending upon whether the ambient light exceeds three transition thresholds. The Tasker ALS data in Figures 6 and 7 are plotted as the highest threshold that has been exceeded. The transition between day and bright day is noted in the figures. Note that, at the transition, the Teledyne ALS measures somewhat over half of the nominal Tasker value. Since the Teledyne sensors have been calibrated at the factory and the Tasker units have never been recalibrated, the error is likely in the Tasker units. Since the RVR value is insensitive to ambient light, this disagreement is not very significant (see Section 3.3.1). In general the ambient light values used by the two systems to calculate RVR were not very different over these periods of time.

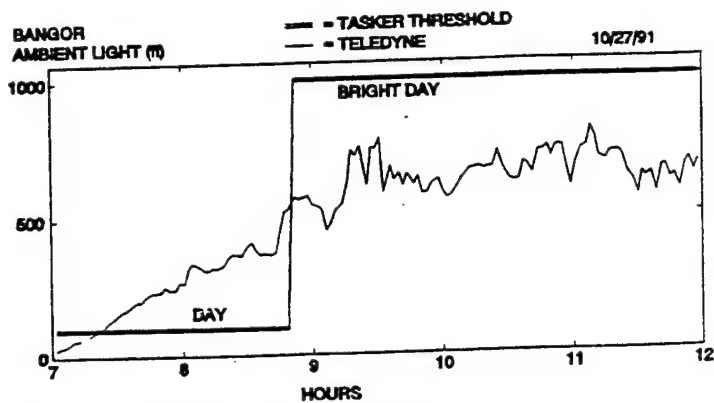
Figure 7. Bangor Ambient Light

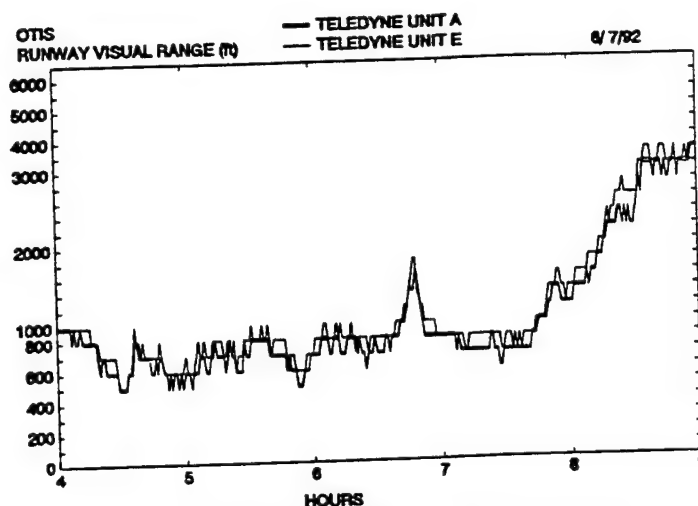
Figure 11. Teledyne RVR Comparison at Otis

The observed calibration differences between different Teledyne sensors have a minimal effect on RVR performance. Figure 11 shows the effects of differing sensor calibration on the calculated RVR (daytime, no runway lights) for the two sensors (Units A and E) with the largest calibration difference of those installed at Otis during Period 3. The RVR values generally differ by at most one reporting increment and often agree exactly. Under conditions where the runway lights are turned on to increase the RVR, the sensor differences would become even less important.

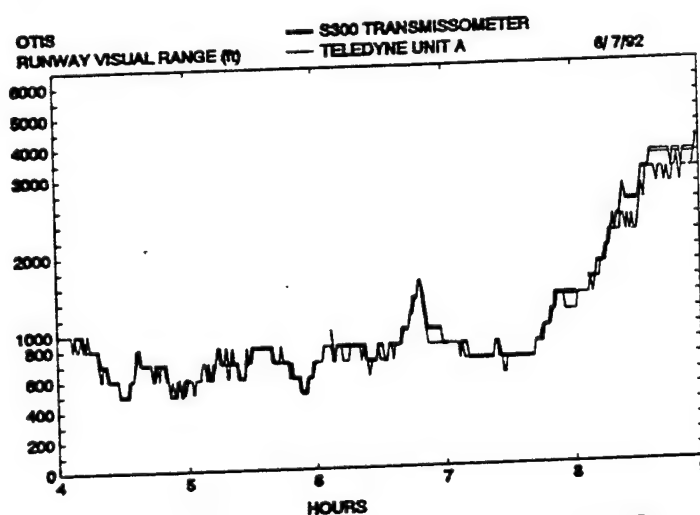
Figure 14. RVR: Teledyne Unit A versus S300

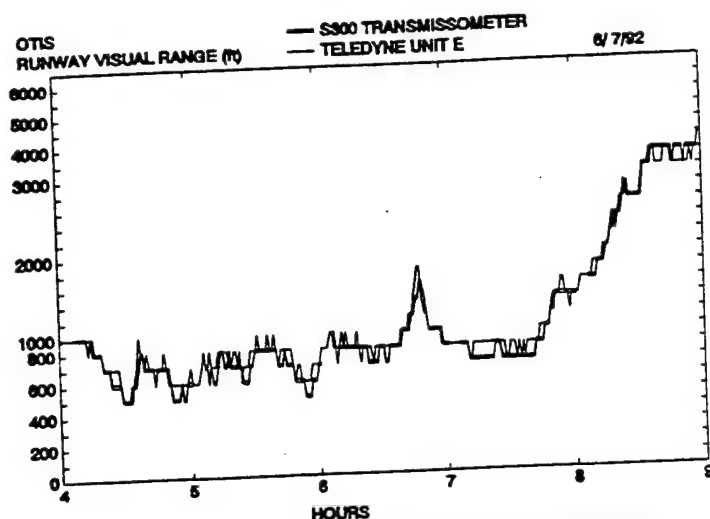
Figure 15. RVR: Teledyne Unit E versus S300

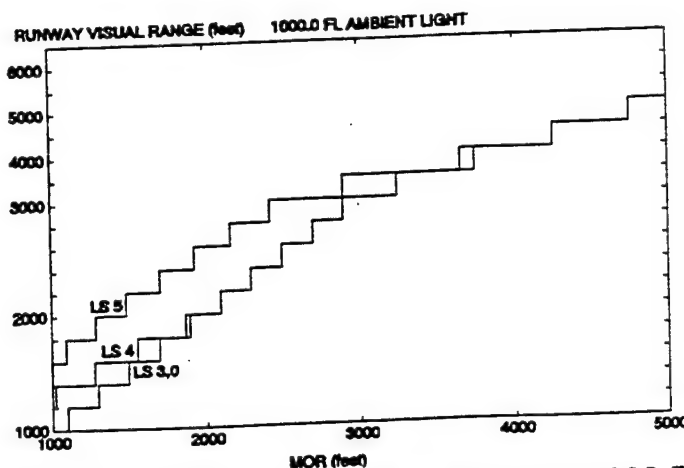
Figure 19. RVR vs. MOR: Ambient Light 1000 Ft-Lmb; Runway Light Settings 5, 4, 3 and 0
